Incorrect Temperature Measurements: “The Importance of Transmissivity and Infrared Windows”

Official Report Excerpt: Summer 2009

At approximately 9:30AM on Monday morning, I began the quarterly inspection of the plants main switch gear (23KV incoming line, distribution switches). All Inspections on the main switch gear were made via 3 inch Calcium Fluoride (CaF2) Crystal Infrared Viewing Panes. The Imager used was a FLIR 695 with standard Emissivity set at 0.92.

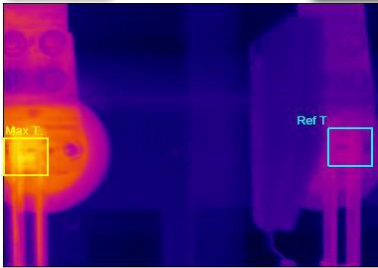
Image 2

Isolation Switch Number Two (Switch 2) has two hot spots: the first anomaly (21 °F ΔT) on the Phase “A” Disconnect contact (Image 2). The second anomaly (30°F ΔT) on the phase “C” Disconnect contact (Image 1).

Label	Value
Max T. : max	146.0°F
Ref T. : max	124.8°F

Delta T 21.19°F

I attended the post repair meeting on Friday. Everyone was in good spirits; “Mission Accomplished” seemed to be the theme. We had just discovered and repaired the most dangerous hot spot our Main Switchgear had ever “seen.” It was decided that the switch #2 hotspots would be monitored daily by the onsite technician’s until a scheduled outage. A new policy was also adopted that put the Main Incoming Switch Yard on a monthly route versus the quarterly scan. (I recommend this to every plant I consult with now).

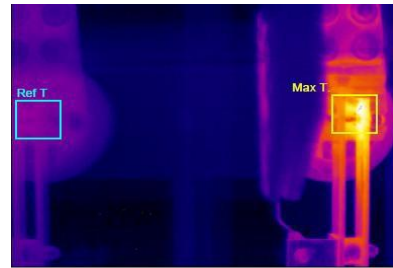
Image 3

Label	Value
Max T. : max	146.9°F
Ref T. : max	117.3°F

Delta T 29.51°F

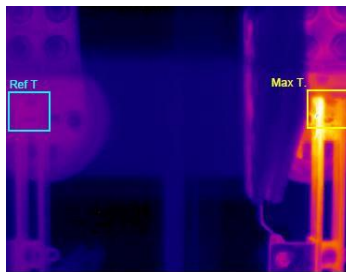
Image 4

Back on site Wednesday morning, I performed a complete scan of all incoming line switchgear. Though all anomalies were still present, I found that switch #1's anomaly had doubled to >60°F ΔT!

Label	Value
Max T. : max	179.6°F
Ref T. : max	119.1°F

Delta T 60.54°F

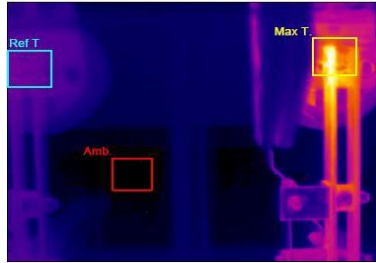
Image 5

The next morning, Thursday, I came in early and scanned the equipment before sunrise. I found and reported that Switch No. 1 had increased to nearly 75°F ΔT. (Image 5) This anomaly had risen 150% in just 3 days!

Label	Value
Max T. : max	211.2°F
Ref T. : max	137.4°F
Amb. : max	118.6°F
Delta T	73.73°F

I captured the images and send out the report. In less than an hour a meeting was held. Reports were sent, calls were made, and the corporate office got involved. Management ordered a decrease in the production rate immediately. No one was willing to let a 75°F ΔT remain in the Incoming Power switch that fed half of the plant. Not on their watch.

The plan was to take Switch #1 offline during a 2 hour power outage that evening. As is sometimes the case, paperwork and part acquisition delayed the repair. Finally, the switch was thrown around 2:00AM Friday morning.

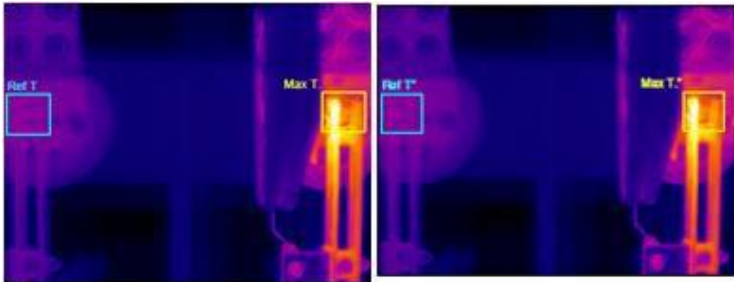
Below are the switch #1 images after Emissivity correction.

Label	Value	Label	Value
Max T. : max	179.6°F	Max T.* : max	239.7°F
Ref T : max	119.1°F	Ref T* : max	150.2°F
Delta T	60.54°F	Delta T	89.52°F

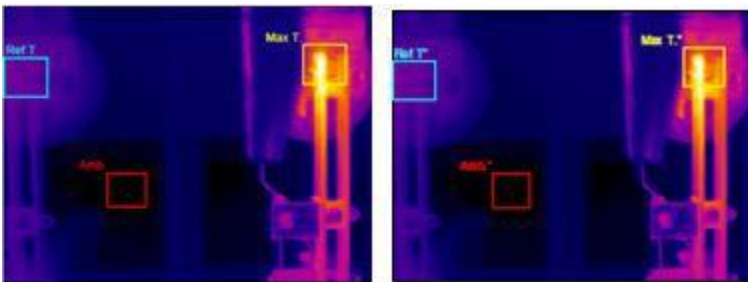
Label	Value	Label	Value
Max T. : max	211.2°F	Max T.* : max	285.1°F
Ref T : max	137.4°F	Ref T* : max	177.8°F
Amb. : max	118.6°F	Amb.* : max	149.4°F
Delta T	73.73°F	Delta T	107.24°F
