Incorrect Temperature Measurements: “The Importance of Transmissivity and Infrared Windows”

Official Report Excerpt: Summer 2009

At approximately 9:30AM on Monday morning, I began the quarterly inspection of the plants main switch gear (23KV incoming line, distribution switches). All Inspections on the main switch gear were made via 3 inch Calcium Fluoride (CaF2) Crystal Infrared Viewing Panes. The Imager used was a FLIR 695 with standard Emissivity set at 0.92.

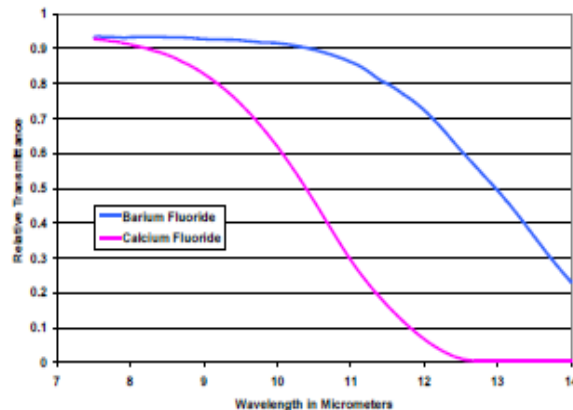
According to the report, transmission rates are typically variable across the infrared spectrum (as shown in Madding, 2004 1), yet the manufacturer’s specified transmission rate is generally relevant for a specific wavelength. So, while a Crystal may indeed have a 95% transmission rate in the short wave, most industrial IR camera operate in the long-(mid) wave or 8-14 μm.

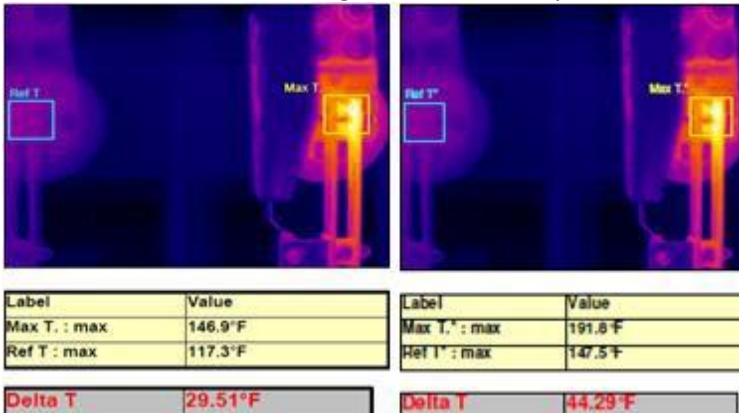
Using the imager’s software, I was able to change the flawed temperature readings I had collected by inputting the correction of .55 Emissivity. The results confirmed the “coffee cup test” and the fact that I had erred in my original calculations. Thermography software as well as many cameras themselves also provides a way to correct for transmission losses. For additional tips contact your window or camera manufacturer. Additional tips can also be found at <http://www.iriss.com>

Below are the switch #1 images after Emissivity correction.
