ROI Case Study 1 – Paper Mill Saves Budget Dollars with IR Window Program

Overview

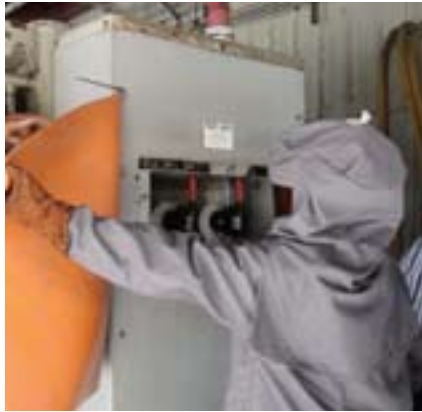
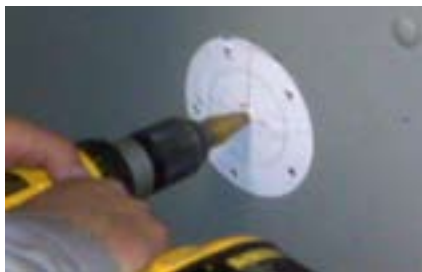
Installation of the infrared inspection panes was conducted during three nights and three days during the ten-day shutdown. Some installations were completed on live gear using additional safety measures; however, the vast majority was conducted on deenergized equipment in what NFPA terms an "electrically safe work condition."

Although our plan allowed for twelve-hour shifts, installers were quickly and safely moving at a rate of approximately six window installations per hour, and were finishing the plant on the night shifts within six hours. Installations during normal business hours allowed much more flexibility; therefore all "live works" were completed during these periods. When the clients' electricians assisted with the installations, the installation rates were also faster than originally planned (7 to 8 windows per hour). All window installations were completed well within the allotted timelines.
